## Chapter 9

# FIRE BEHAVIOR IN WORLD TRADE CENTER 2

### 9.1 INTRODUCTION

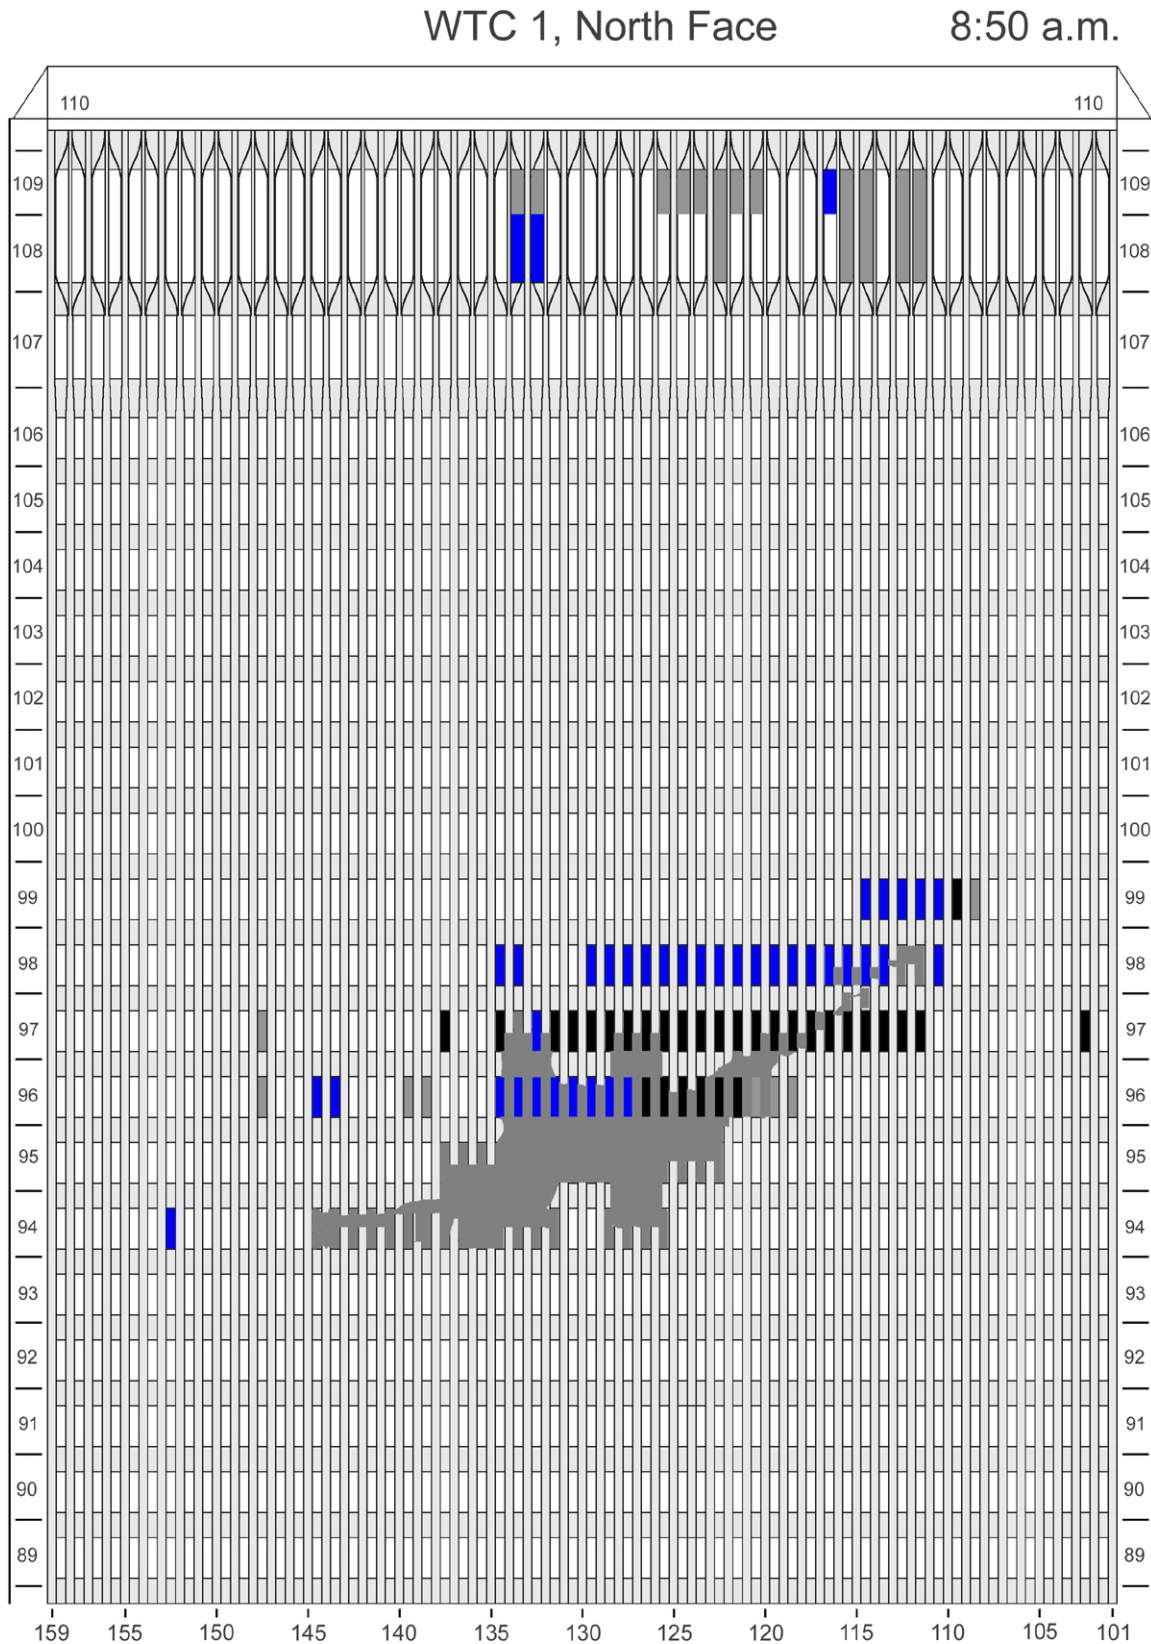
**Figure C-6. Diagram of the north face of WTC 1 for floors 89 to 110 at 8:50 a.m. showing windows where smoke was observed and those that were hidden from view.**

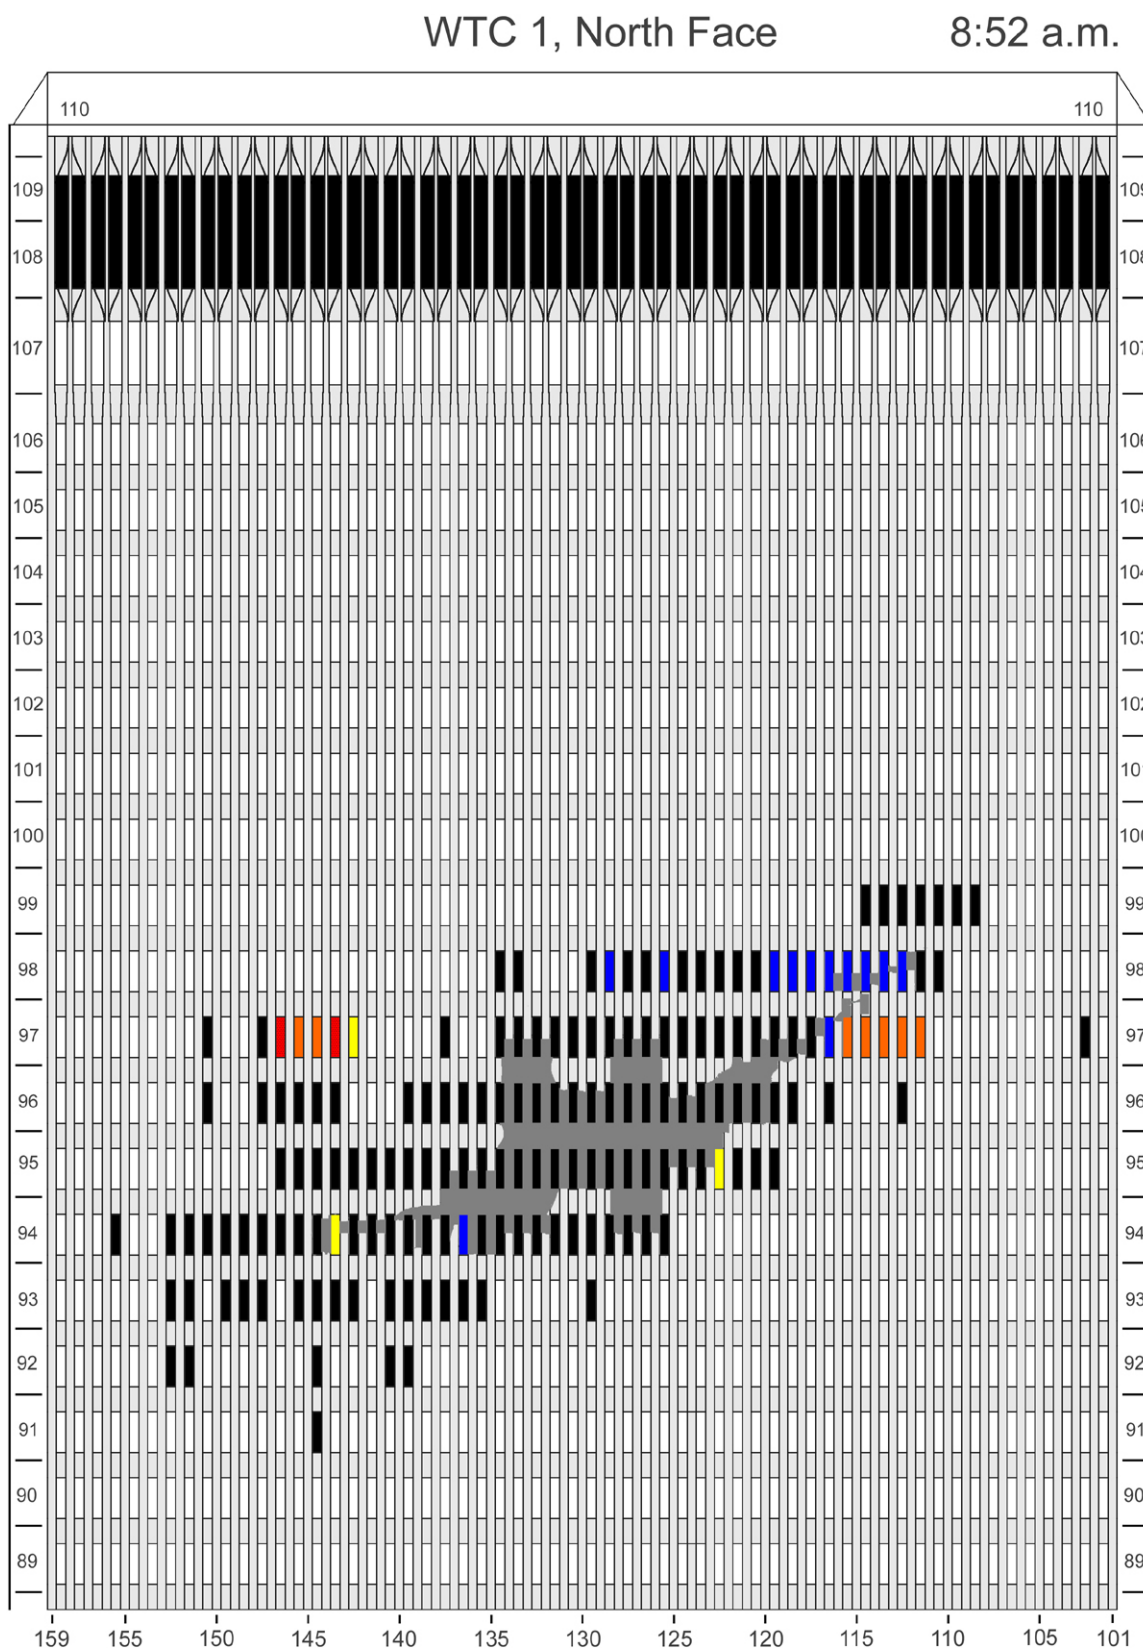
**Figure C-7. Diagram of the north face of WTC 1 for floors 89 to 110 at 8:52 a.m. showing the condition of windows and locations of fires.**

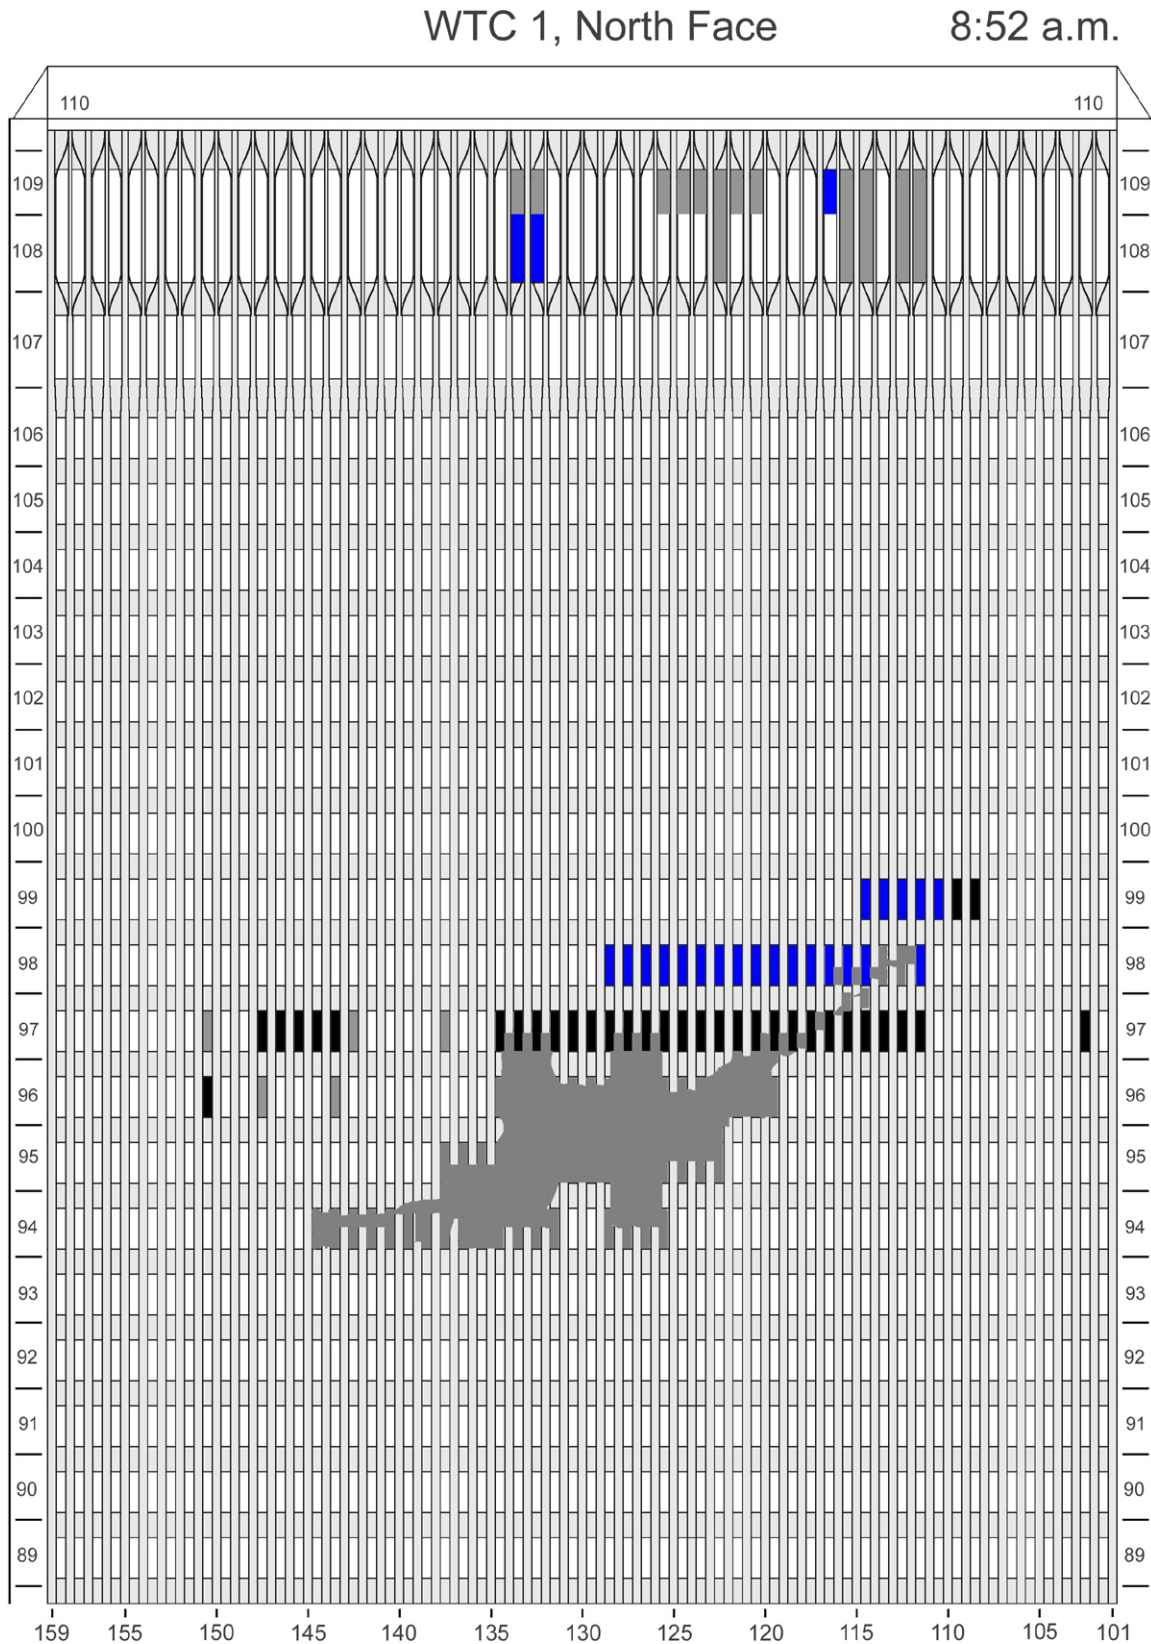
**Figure C-8. Diagram of the north face of WTC 1 for floors 89 to 110 at 8:52 a.m. showing windows where smoke was observed and those that were hidden from view.**

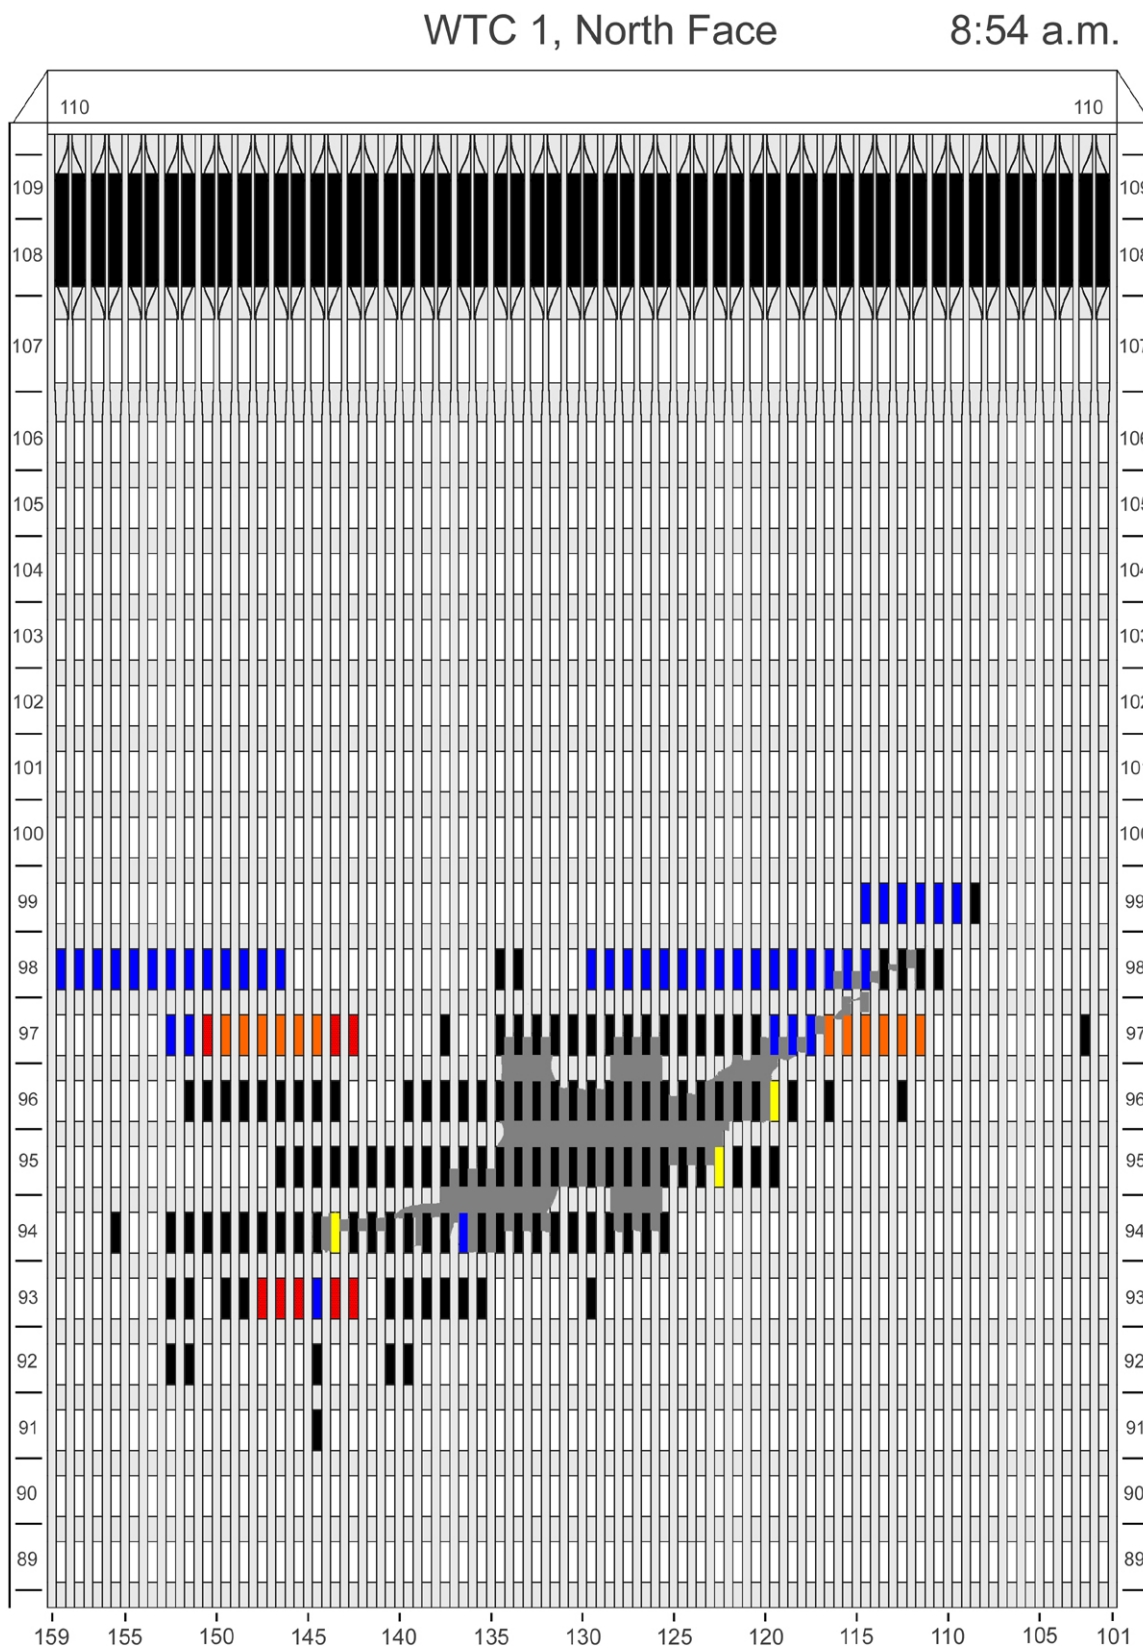
**Figure C-9. Diagram of the north face of WTC 1 for floors 89 to 110 at 8:54 a.m. showing the condition of windows and locations of fires.**

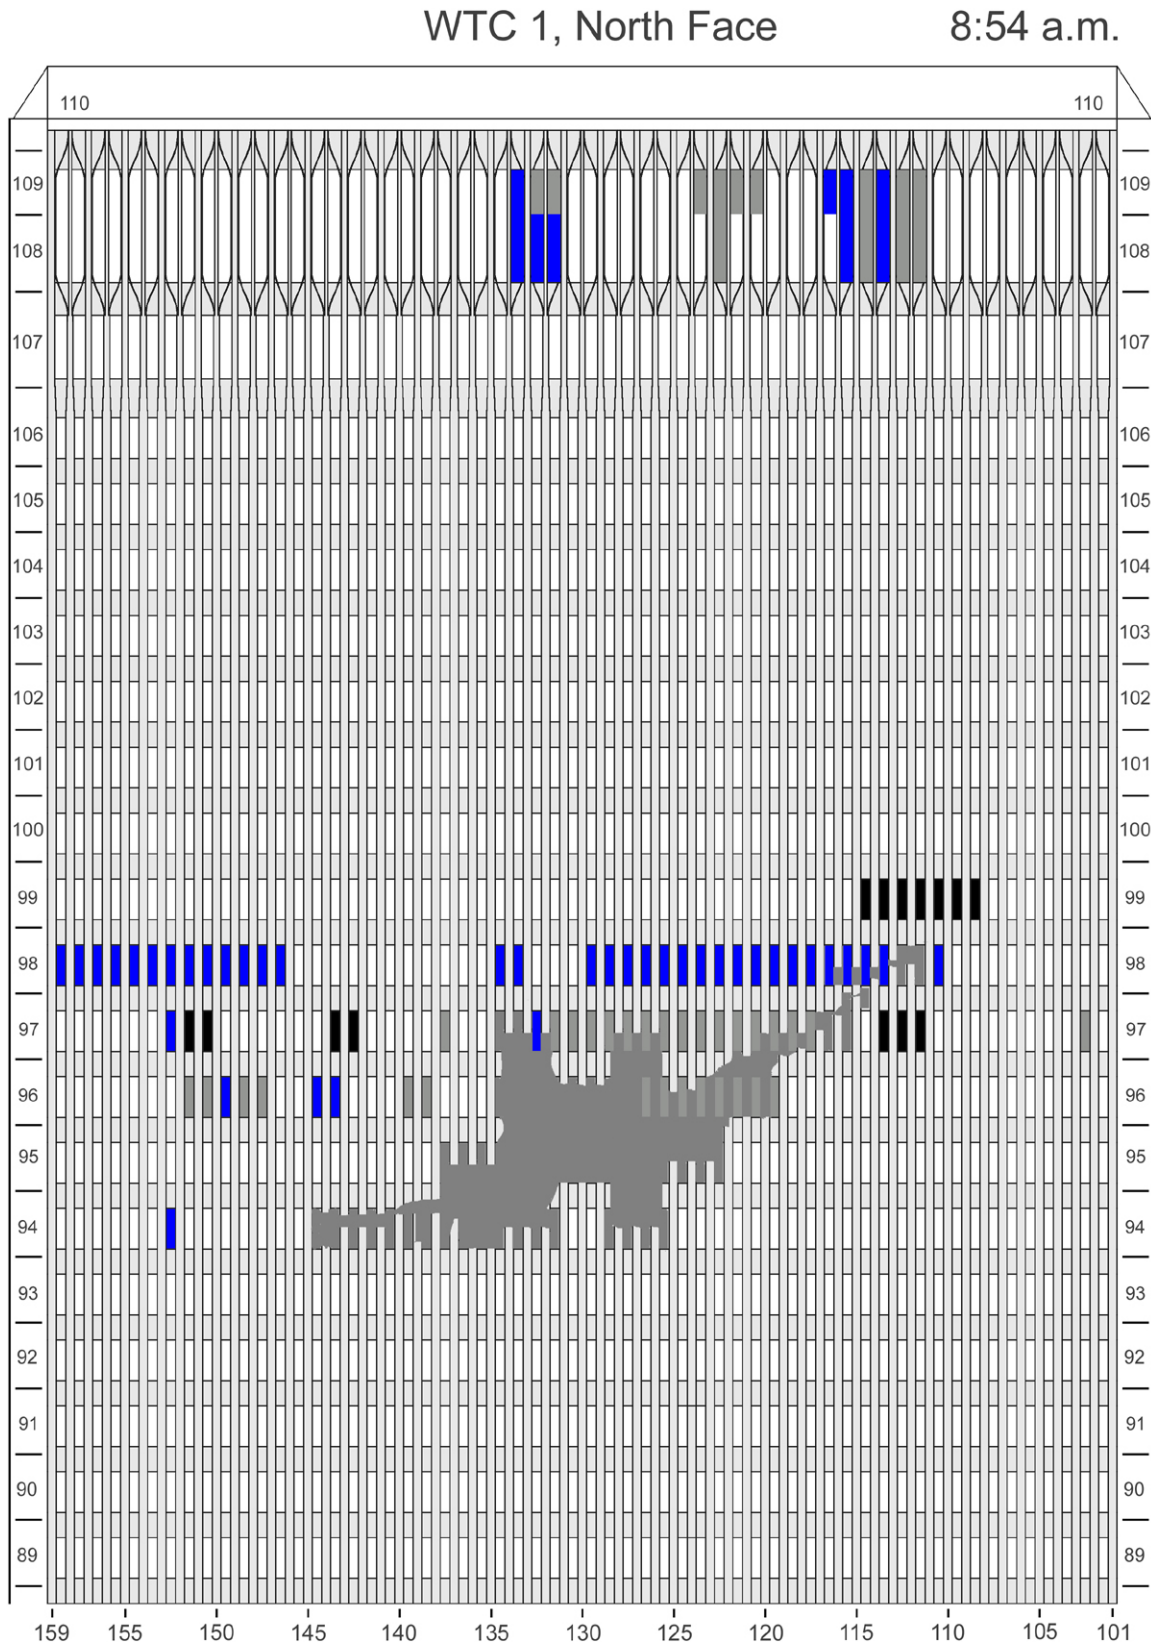
**Figure C-10. Diagram of the north face of WTC 1 for floors 89 to 110 at 8:54 a.m. showing windows where smoke was observed and those that were hidden from view.**

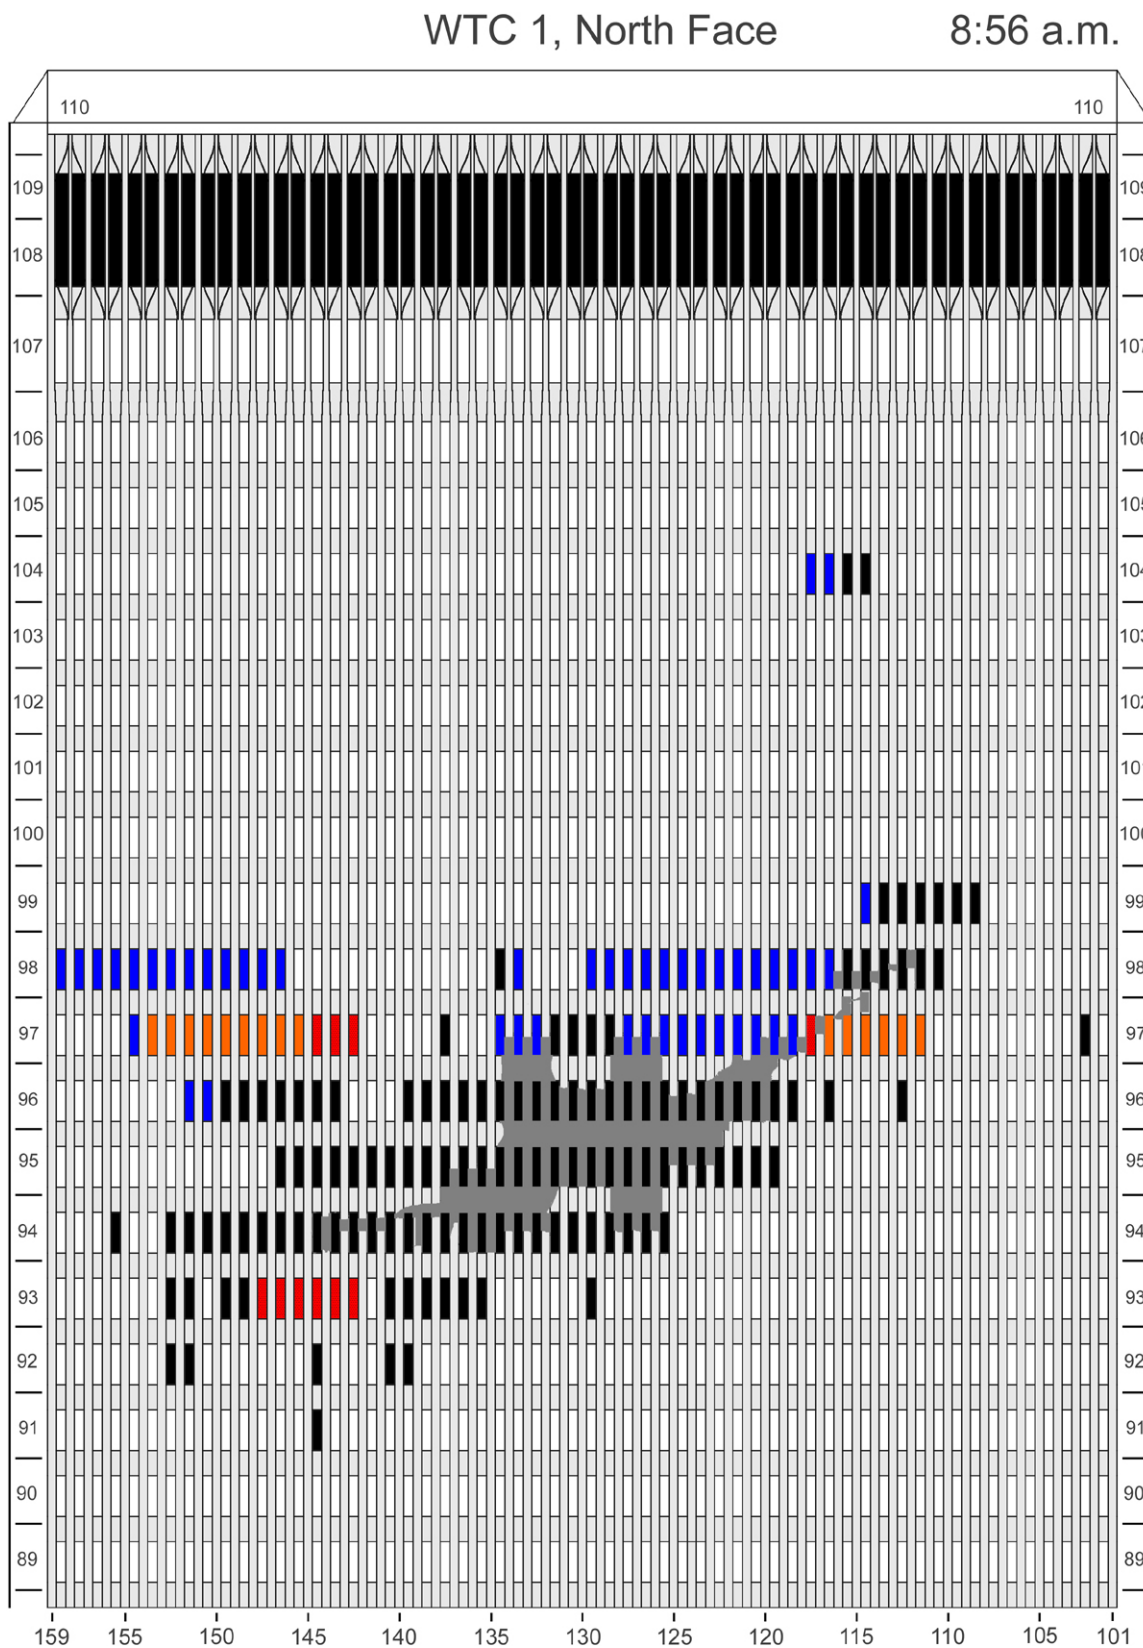
**Figure C-11. Diagram of the north face of WTC 1 for floors 89 to 110 at 8:56 a.m. showing the condition of windows and locations of lines.**

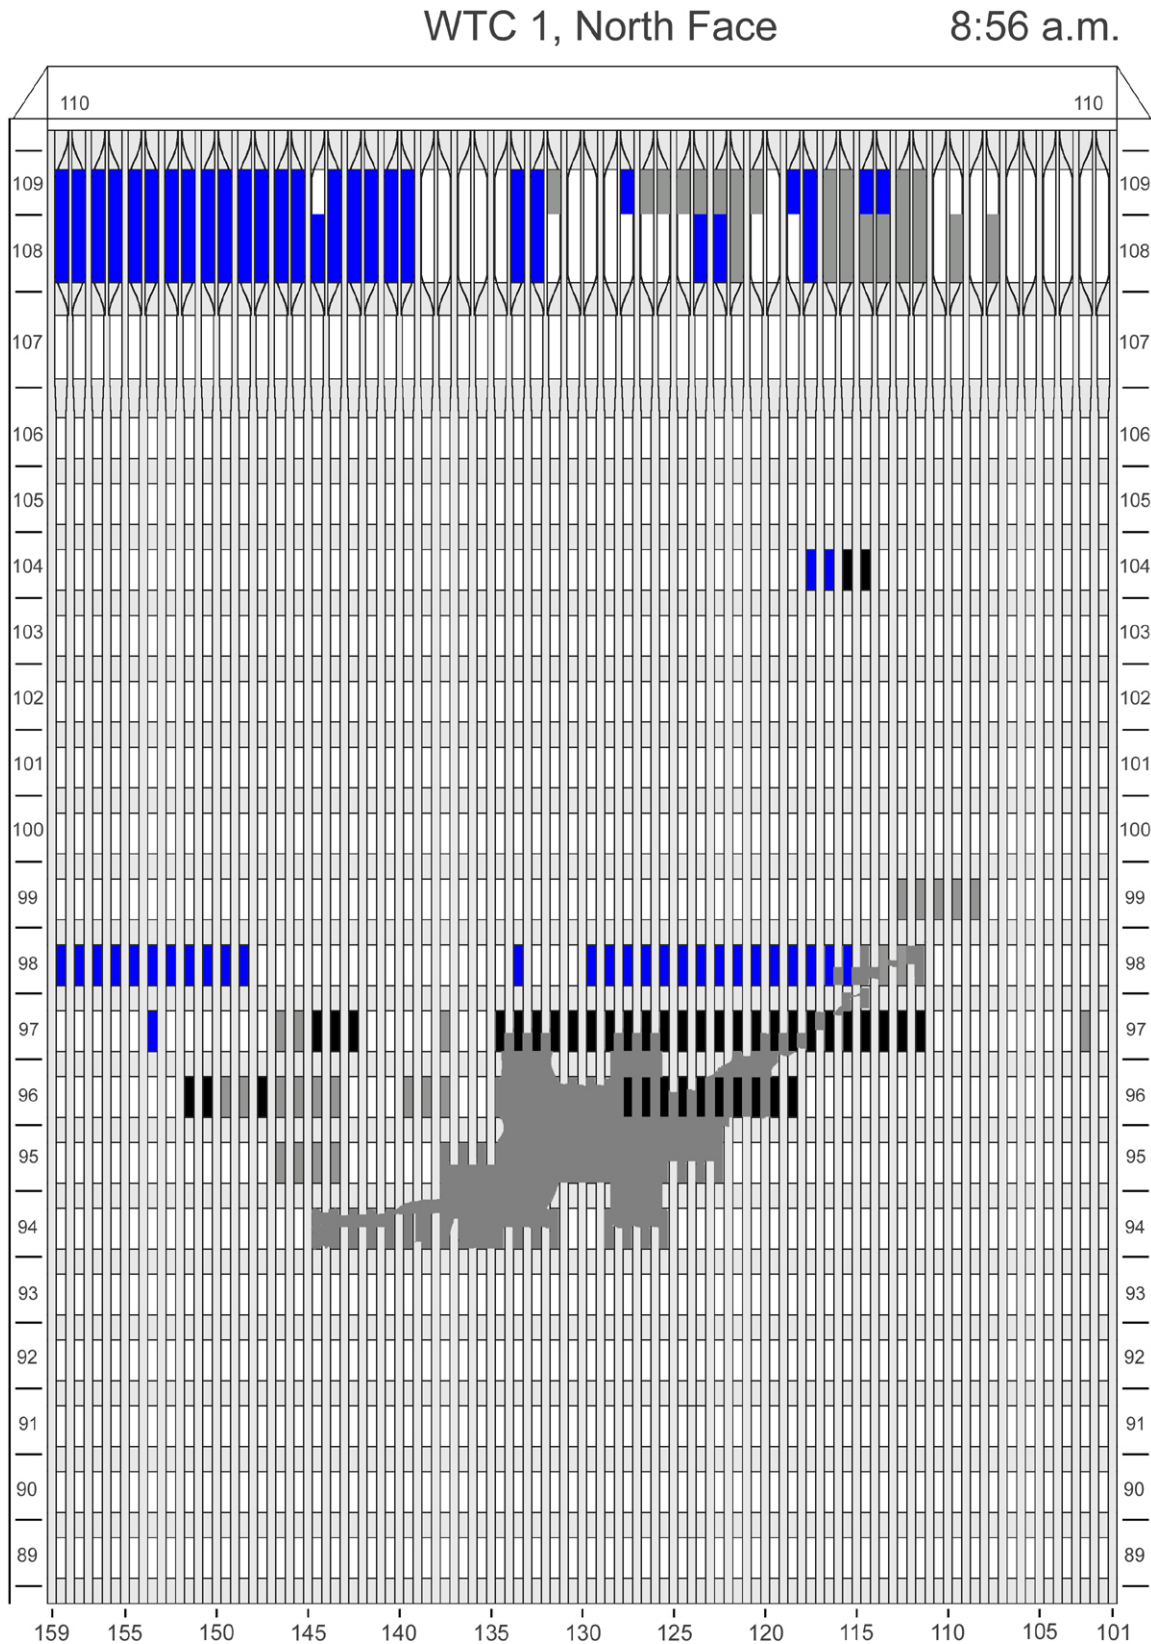
**Figure C-12. Diagram of the north face of WTC 1 for floors 89 to 110 at 8:56 a.m. showing windows where smoke was observed and those that were hidden from view.**

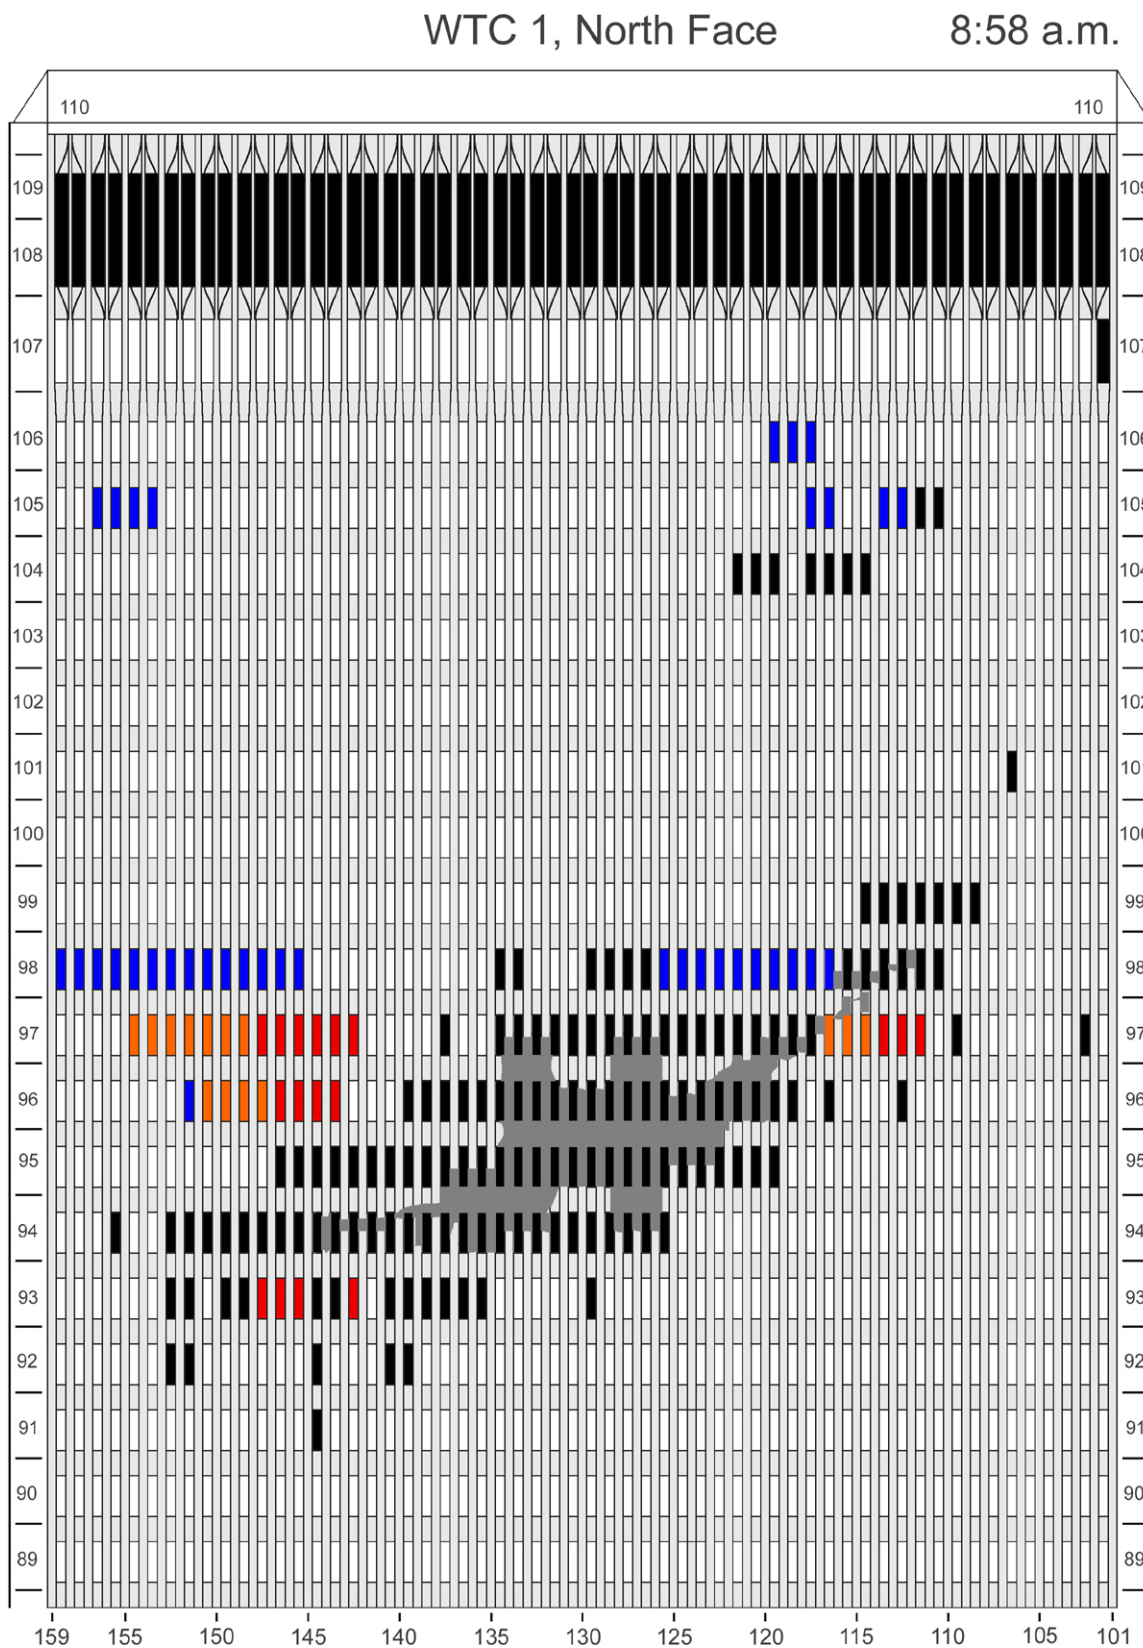
**Figure C-13. Diagram of the north face of WTC 1 for floors 89 to 110 at 8:58 a.m. showing the condition of windows and locations of fires.**

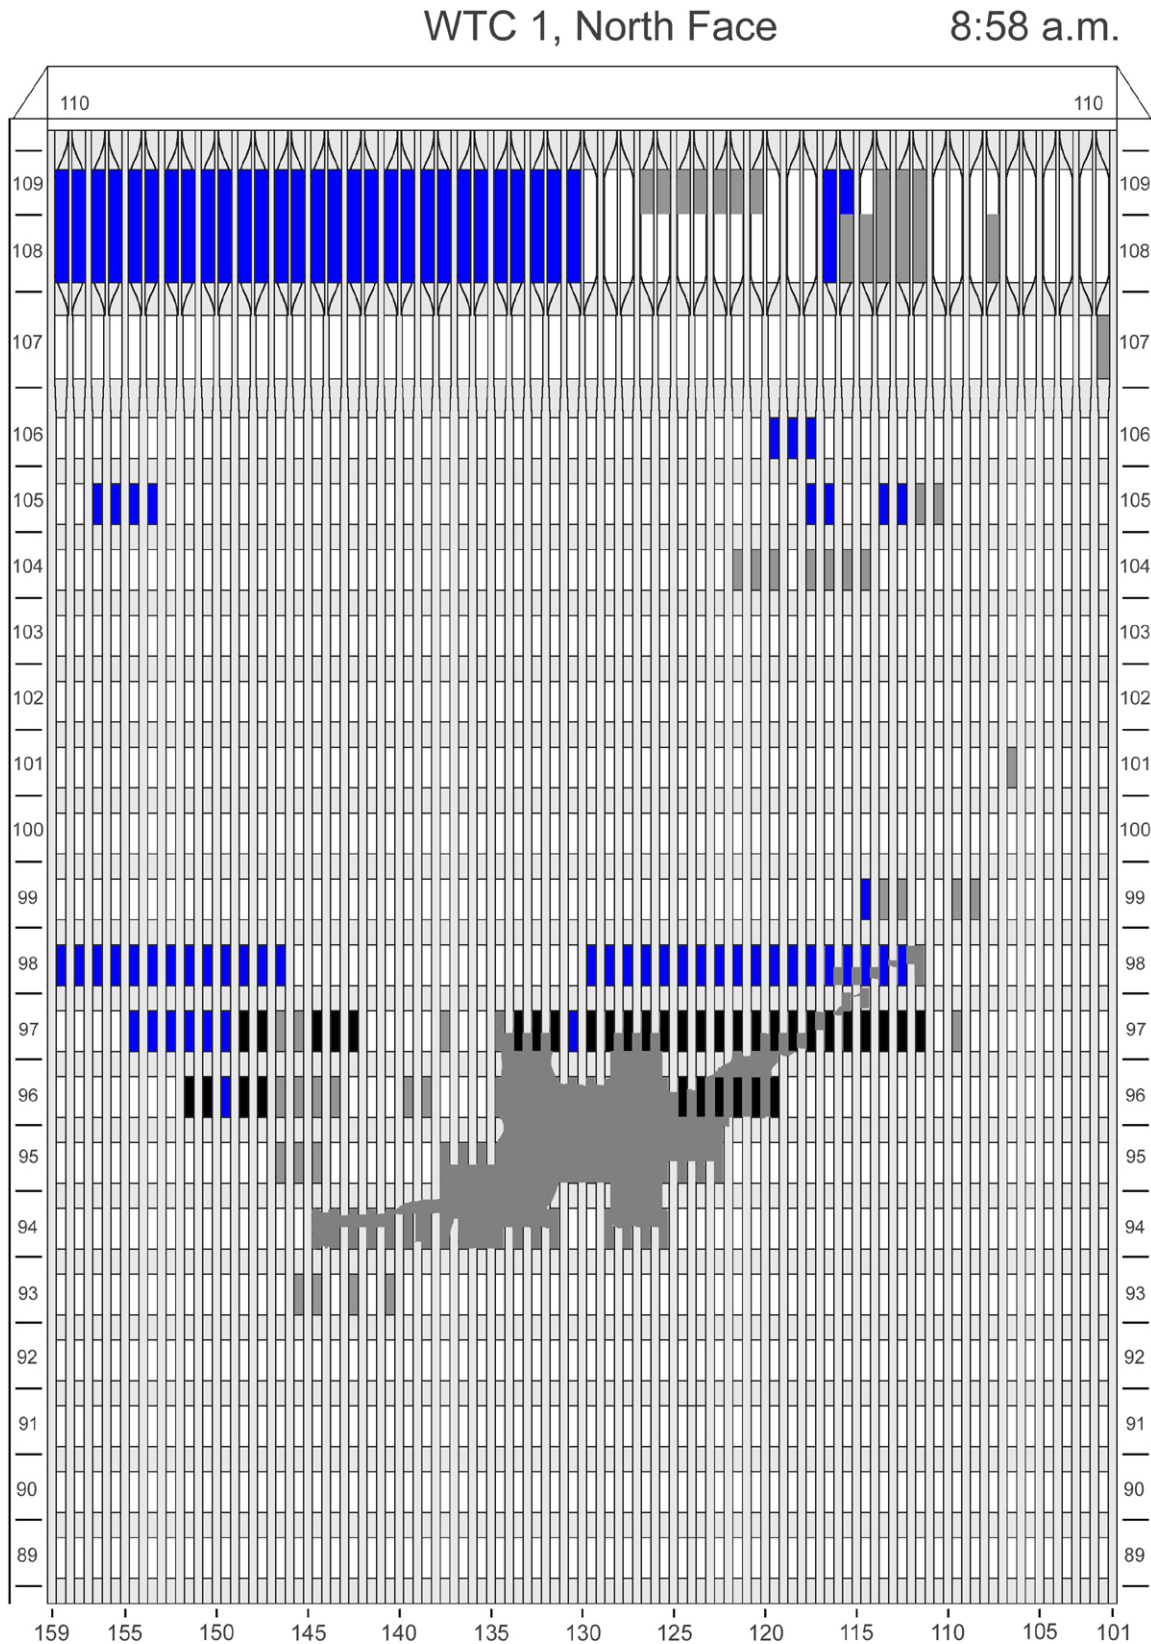
**Figure C-14. Diagram of the north face of WTC 1 for floors 89 to 110 at 8:58 a.m. showing windows where smoke was observed and those that were hidden from view.**

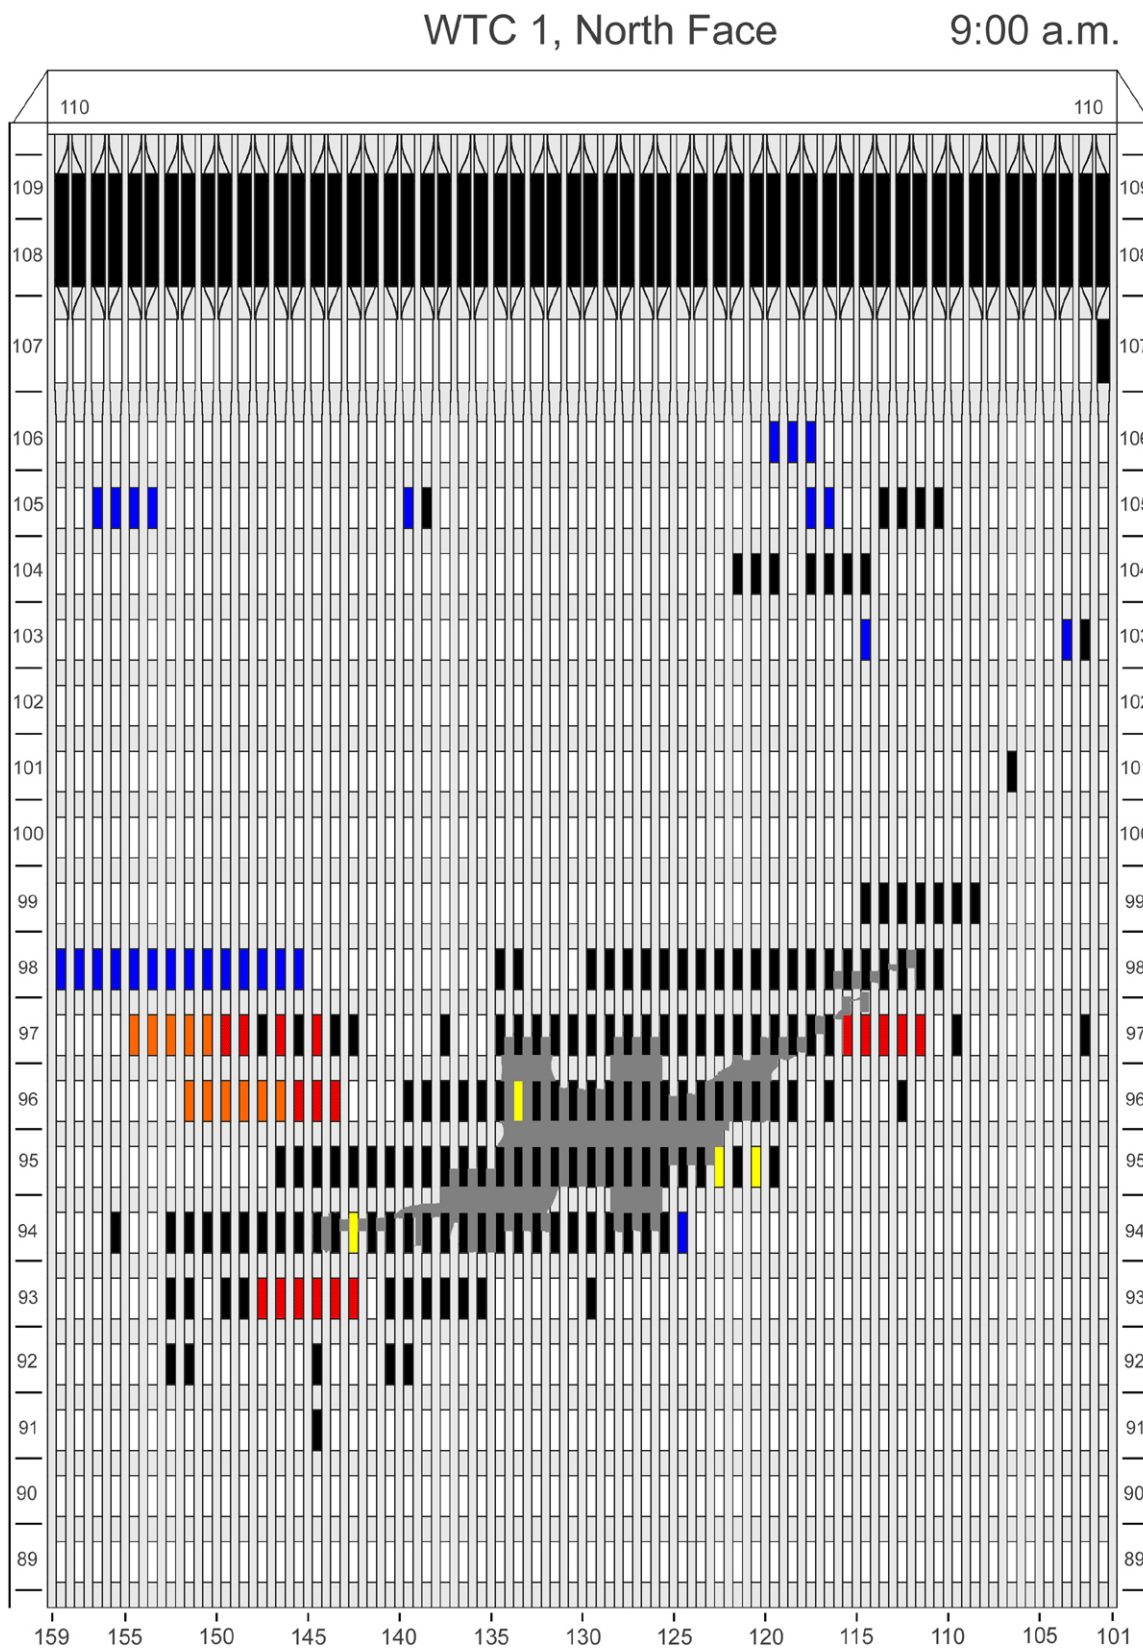
**Figure C-15. Diagram of the north face of WTC 1 for floors 89 to 110 at 9:00 a.m. showing the condition of windows and locations of fires.**

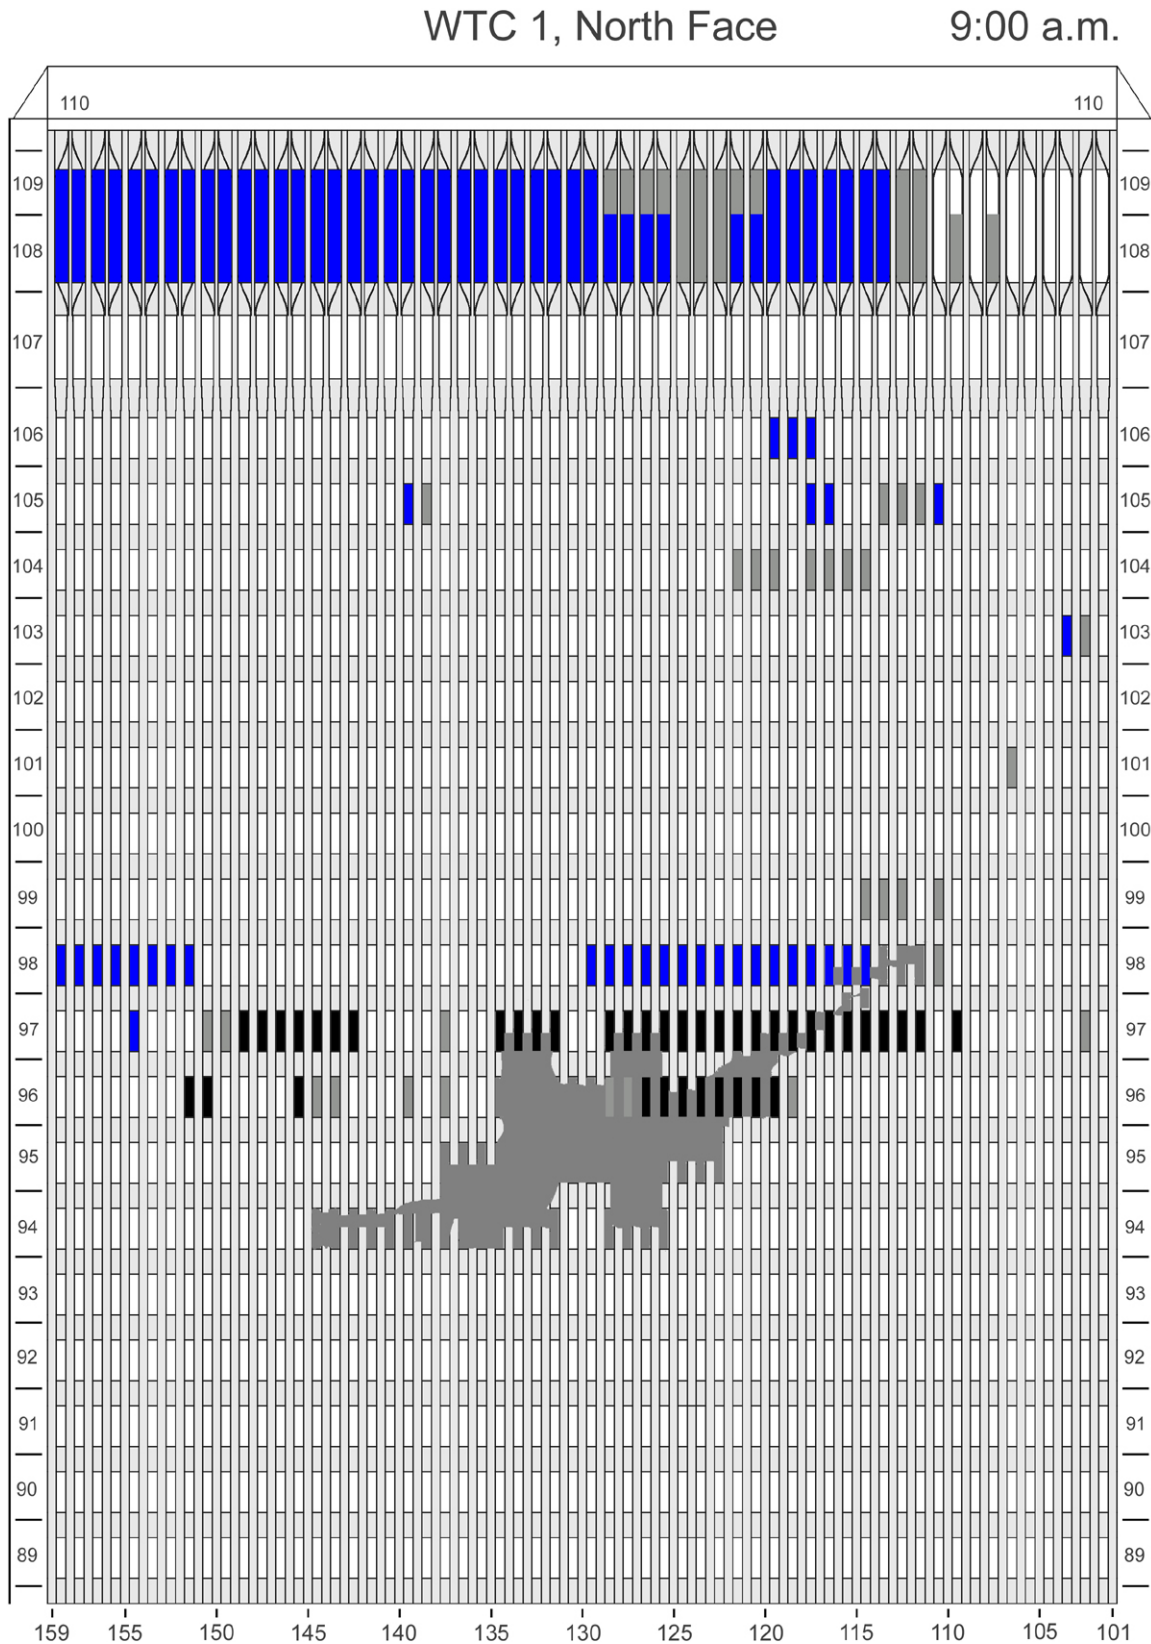
**Figure C-16. Diagram of the north face of WTC 1 for floors 89 to 110 at 9:00 a.m. showing windows where smoke was observed and those that were hidden from view.**

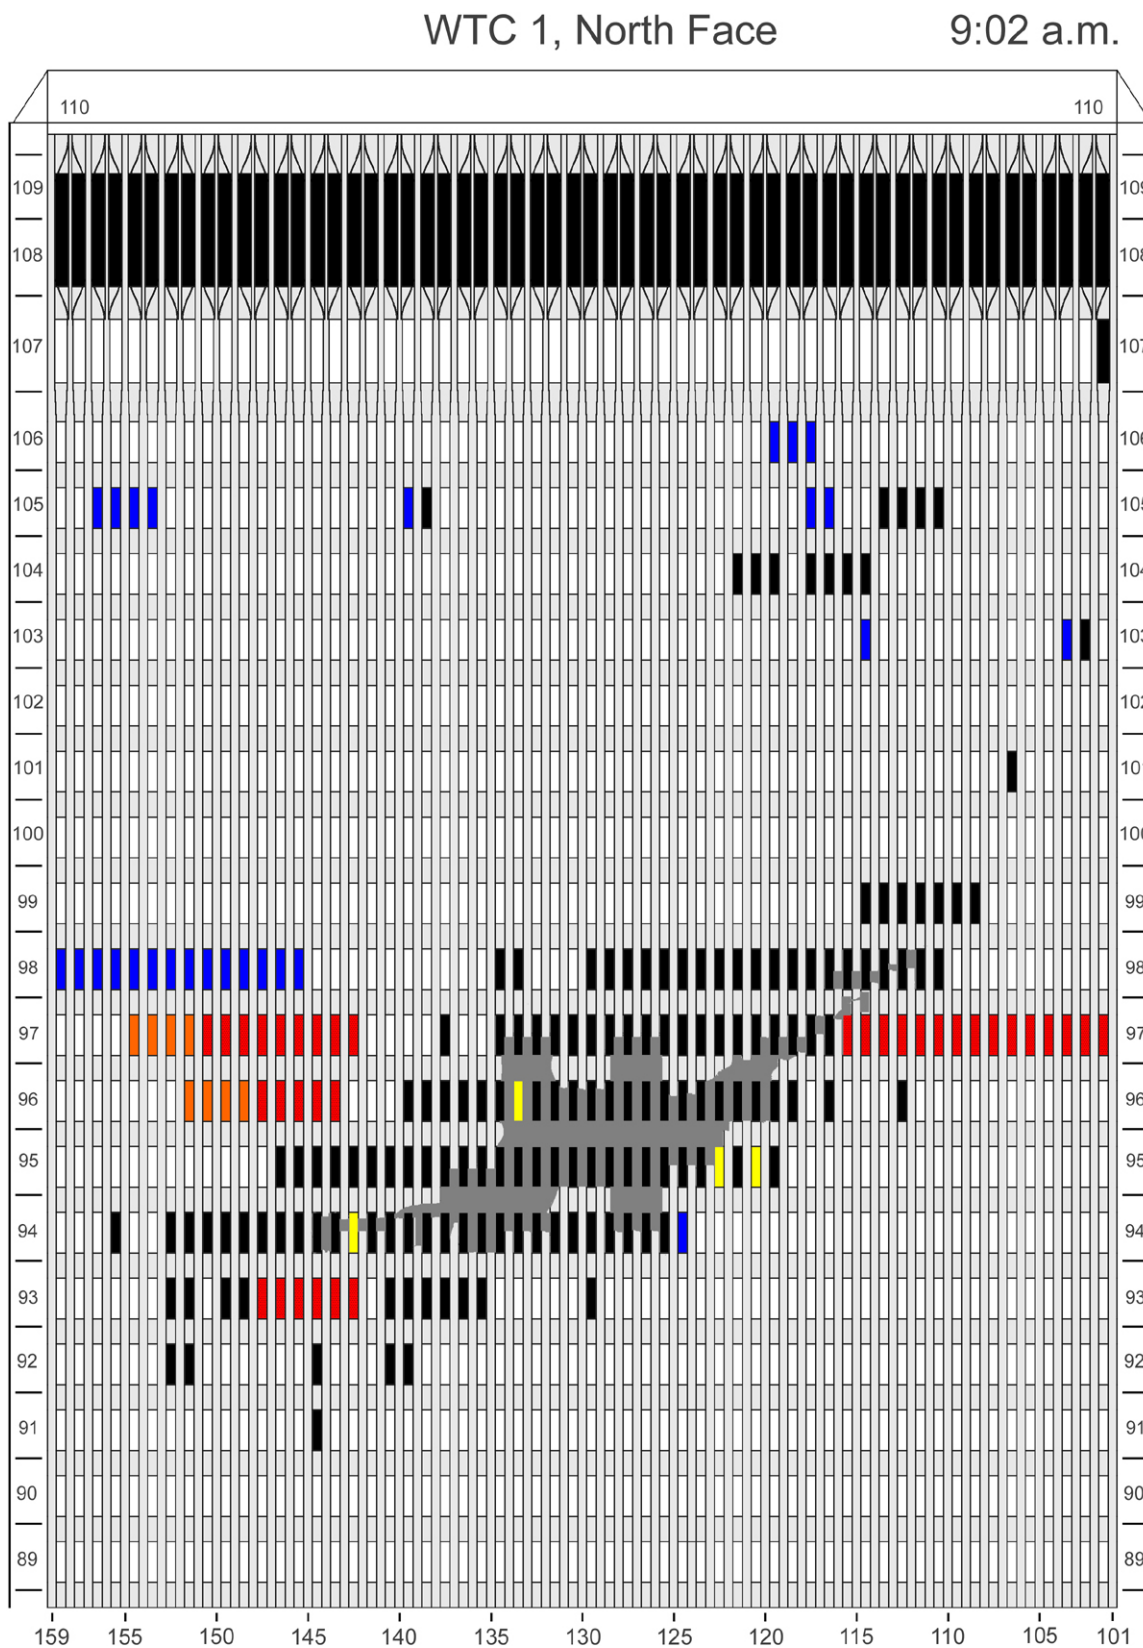
**Figure C-17. Diagram of the north face of WTC 1 for floors 89 to 110 at 9:02 a.m. showing the condition of windows and locations of fires.**
